# Manhole Inspection Summary

Manhole # S29G\_\_002MH

Insp Date: **8/4/08 10:28 AM**

**Location** Address: **655 w baltimore st**

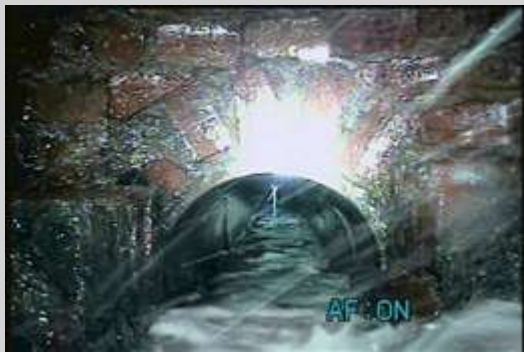
12 O'Clock Outflow

10 in. Circular Gravity Sewer  
Pipe Out @ 12 O'Clock

Pipe Material: Clay ☐ Pipe Lined

Invert Depth: 13.25 (ft.) Flow Characteristics: Fast

Deposits: ☒ None ☐ Mud ☐ Sludge ☐ Debris ☐ Grease

Infiltration: None Pipe Seal Cond: Unknown

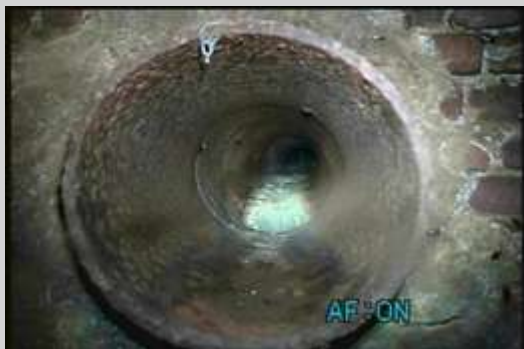
4 O'Clock Inflow

10 in. Circular Gravity Sewer  
Pipe In @ 4 O'Clock

Pipe Material: Clay ☐ Pipe Lined

Invert Depth: 9.41 (ft.) Flow Characteristics: Fast

Deposits: ☒ None ☐ Mud ☐ Sludge ☐ Debris ☐ Grease

Infiltration: None Pipe Seal Cond: Unknown

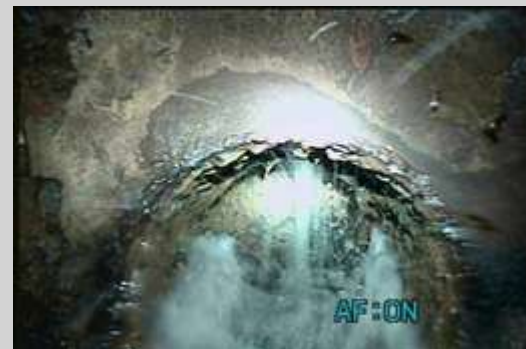
Drop In @ 4 O'Clock

Drop: Outside Direct

Inv Depth: 12.92 (ft.)

Drop Condition: Open

Connects To: House connection / Service line

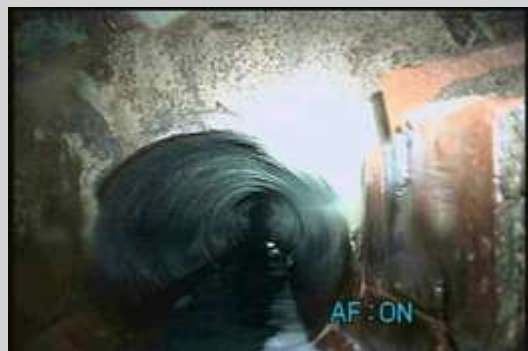
6 O'Clock Inflow

10 in. Circular Gravity Sewer  
Pipe In @ 6 O'Clock

Pipe Material: **Clay** ☐ Pipe Lined

Infiltration: **None** Pipe Seal Cond: **Unknown**
